Issue 01 November 2016 Steve Hill

## CRAYKE CASTLE, CRAYKE, NORTH YORKSHIRE, GAZETTEER CONTENTS

This Gazetteer has been written to accompany the Conservation Management Plan for Crayke Castle. It is a record of the building as its stands in August 2016 and is intended for use as a reference guide to allow anyone planning changes, from a professional considering major works to maintenance contractors dealing with ad hoc repairs, to quickly check the status of a room or building. The Gazetteer should also alert readers to the fact that they need to refer to the wider Conservation Management Plan, undertake further investigation before carrying out work that could have an impact on historic significance or apply for the relevant permission for work.

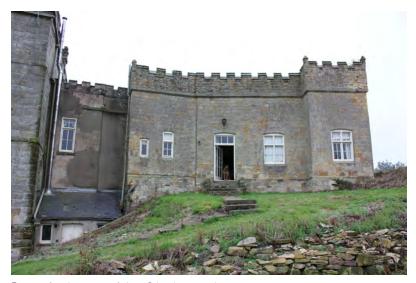
Eastern elevation – general view of victorian extension

The structure has some historic value as a part of the development of the castle. However, it is of poor quality design and build and suggests economy in its construction. It has a negative impact on the views of the castle in its surroundings. This elevation is also in poor condition. It is of **Low Significance**.

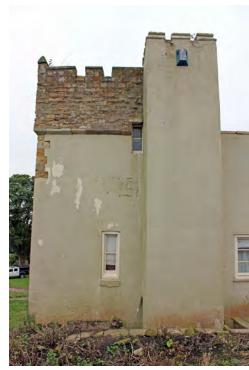
Northern Elevation

The structure has some historic value as a part of the development of the castle. However, it is of poor quality design and build and suggests economy in its construction. It has a negative impact on the views of the castle in its surroundings. This elevation is also in poor condition. It is of **Low Significance**.

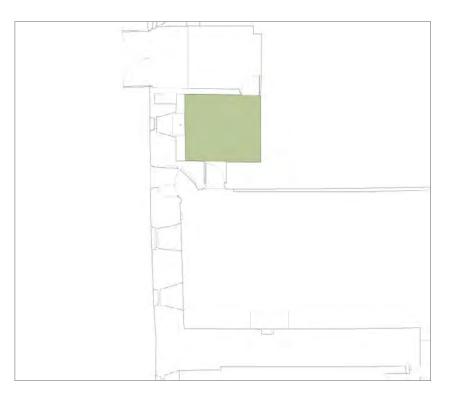
CEILING	Modern suspended plasterboard ceiling in poor condition.
WALLS	Mainly stone construction with plastered finish. The south west corner shows evidence of the corbelled underside of an earlier staircase which led from the undercroft to a medieval kitchen above. The northern wall is of brick.
FLOORS	Two steps up from the Kitchen with quarry tiled floor.
DOORS	Timber ledged and braced boarded door through rounded arch from Kitchen (GF06).  Ledge and brace timber door to Freezer Room (GF08).
WINDOWS	Splayed window in west wall above sink with timber casement window.
OTHER FEATURES	Fixtures including taps, lead pipework, stone worktops and stone sink supported on white glazed bricks. Modern shelving to north wall.

KEY FEATURES		INTRUSIVE FEATURES	
•	Evidence of spiral staircase in south-west corner	•	Poor overall condition with widespread damp
•	Nineteenth century scullery fittings Stone walls and medieval doorcase	•	Lead pipework

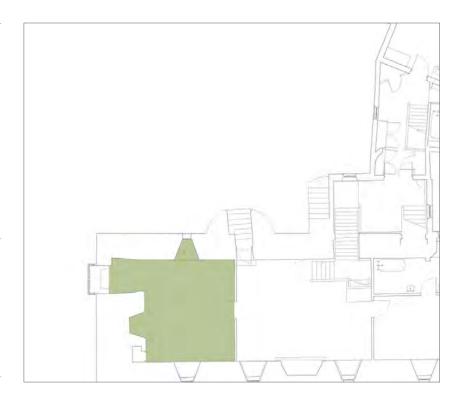
CEILING	Heavily moulded ceiling beams which feature a double hollow chamfer and step mouldings. Lath and plaster between beams. Timber cornice added below beams at room edge on east and west walls.
WALLS	Painted stone cornice in north and south walls indicates where the floor level above steps in. Iron hooks below the cornice, possibly used for the decorative hangings.
	Exposed rubble walls in the window alcove on the west wall and fragments of historic wall plaster. It is believed that the alcove is the location of a medieval spiral staircase.
FLOORS	Modern floating timber floor above earlier floor boards. Skirting board above is modern.
	Brick floor to small cupboard left of fireplace.
DOORS	Six-panel timber door with moulded architrave, corner squares and plinth blocks at base of door frame.
WINDOWS	South wall – deep splayed opening with narrow rectangular six-light timber casement window.
	The west wall has a deep alcove set with an oriel window with window seat.  Timber casement with Gothic tracery possibly dates to the late nineteenth or early twentieth century. It is now in poor condition.

North wall has small four light window in deep splay, partially bricked up due to the height of terrace on this elevation. The window has a modern timber feature surround with broken pediment above.
OTHER FEATURES	Plastered fireplace in west wall partially inserted with brick next to corner cupboard that is also brick infill.
	Modern services with external pipework and small cast iron radiators to north and east walls.

KEY FEATURES	INTRUSIVE FEATURES
<ul> <li>Stone cornice</li> <li>Original ceiling beams</li> <li>Metal hooks</li> <li>Lath and plaster ceilings</li> <li>Evidence of earlier staircase</li> <li>Built in cupboard</li> </ul>	<ul> <li>Modern exposed pipework</li> <li>Blocked up window to north wall</li> <li>Water ingress and general condition</li> </ul>

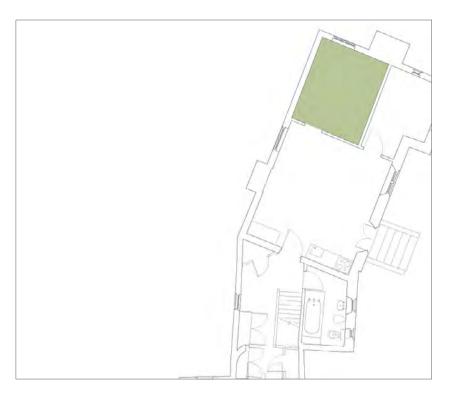
CEILING	Painted timber chamfered beams with painted modern board between.
WALLS	Painted plaster to north, east and west walls with painted timber tongue and groove wainscot below a dado. South partition wall is entirely tongue and groove with dado. Moulded skirting.
FLOORS	Lacquered timber floor boards.
DOORS	Three-panel timber doors to Sitting Room (EX03) with moulded architrave.
WINDOWS	Square six-light timber casement in north wall.
OTHER FEATURES	Exposed pipework and cast iron radiator.
	Hearth stone against north wall indicating position of blocked fireplace.
	Cast iron vent at high level on north wall.
	Caste iron radiator and exposed pipework.

KEY FEATURES	INTRUSIVE FEATURES
<ul><li>Moulded ceiling beams</li><li>Tongue and groove wainscot</li><li>Cast iron vent</li><li>Hearth stone</li></ul>	<ul> <li>Overall condition with severe water ingress to north wall</li> <li>Exposed pipework</li> </ul>

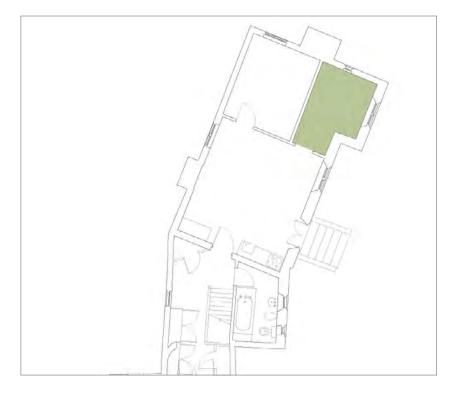
CEILING	Timber chamfered beams with modern board between.
WALLS	Painted plaster to north, east and west walls with painted timber tongue and groove wainscot below a dado. South partition wall is entirely tongue and groove with dado. Moulded skirting.
FLOORS	Lacquered timber floor boards.
DOORS	Three-panel timber doors to Sitting Room (EX03) with moulded architrave.
WINDOWS	Timber mullion casement window with sill in east wall and narrow two-light casement in north wall.
OTHER FEATURES	Exposed pipework and cast iron radiator

KEY FEATURES	INTRUSIVE FEATURES
<ul><li>Moulded ceiling beams</li><li>Tongue and groove wainscot</li></ul>	<ul><li>Overall condition with severe water ingress to north wall</li><li>Exposed pipework</li></ul>
