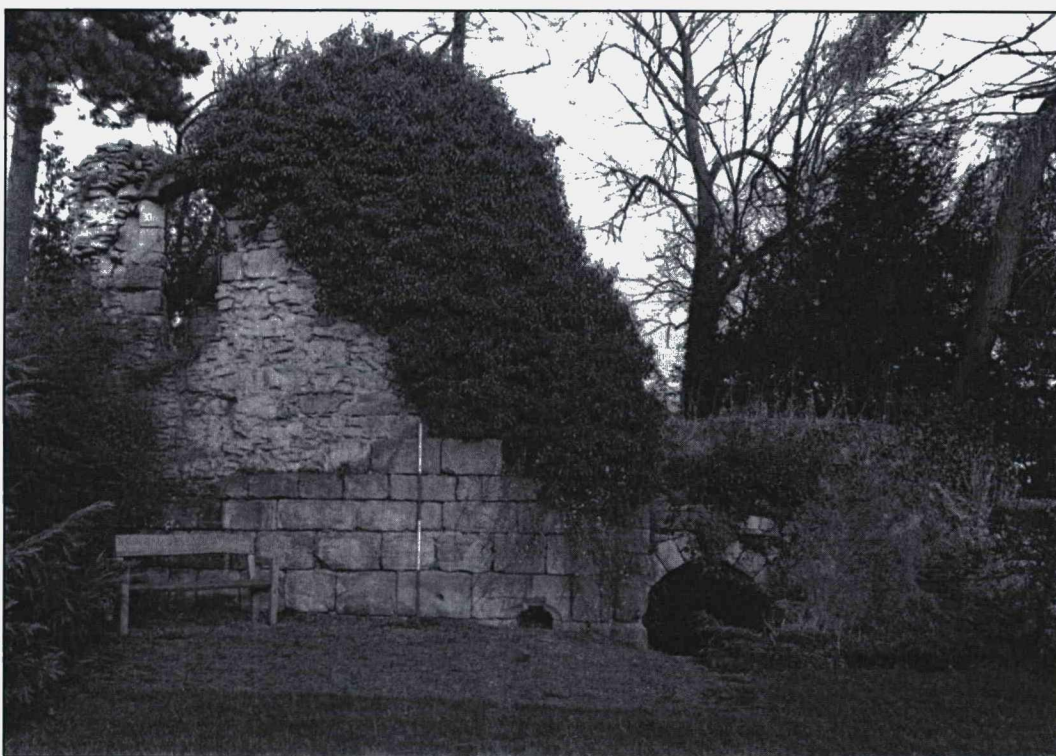
Plate 2: South elevation prior to vegetation removal and consolidation, looking N (photo 1/1).

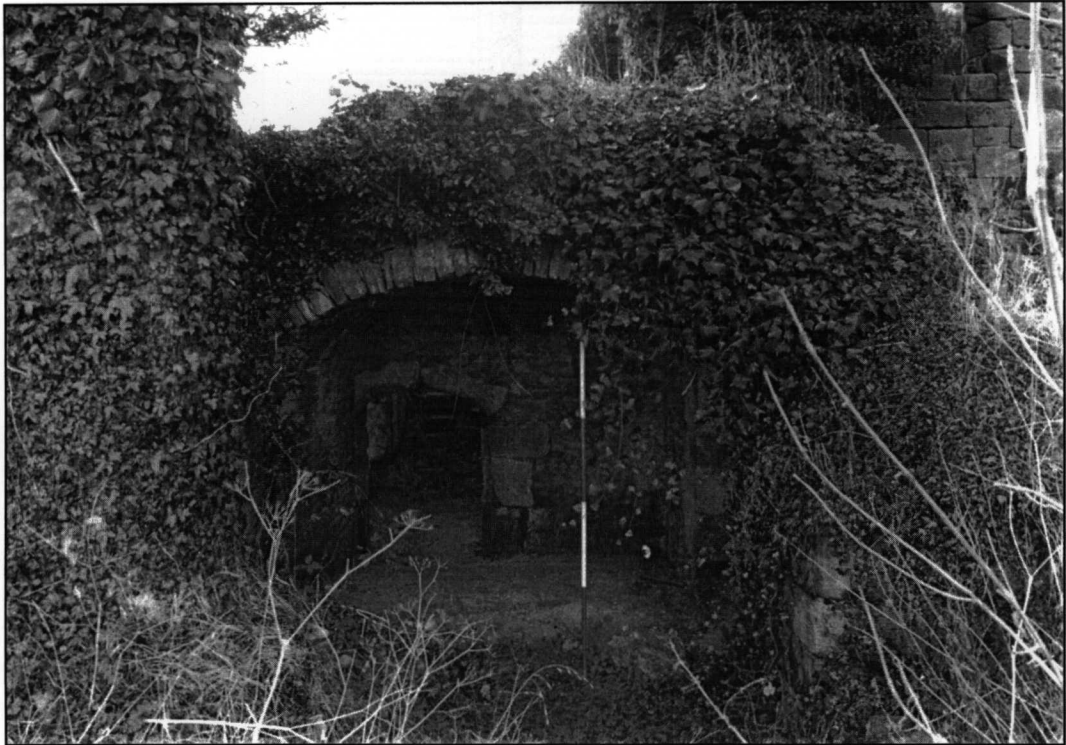
Plate 3: View into room E prior to consolidation, looking S (photo 1/16).

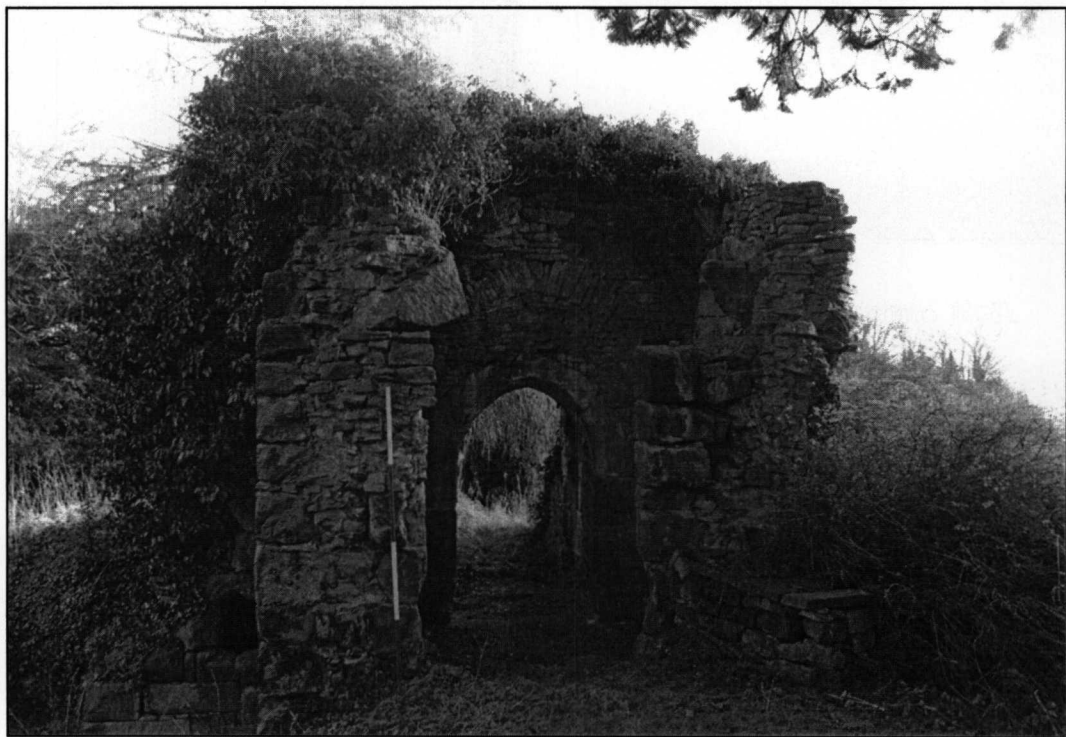
Plate 4: View into lobby (A) prior to consolidation, looking E (photo 1/11).

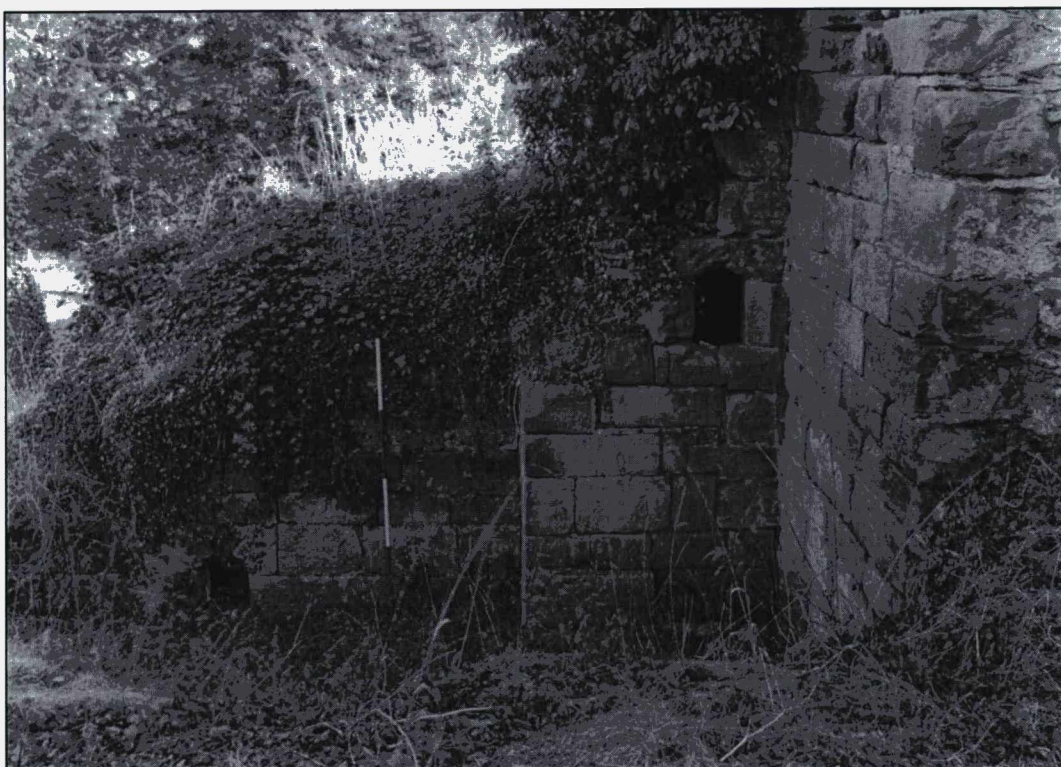
Plate 5: Part of west elevation prior to vegetation clearance and consolidation, looking E (photo 1/8).

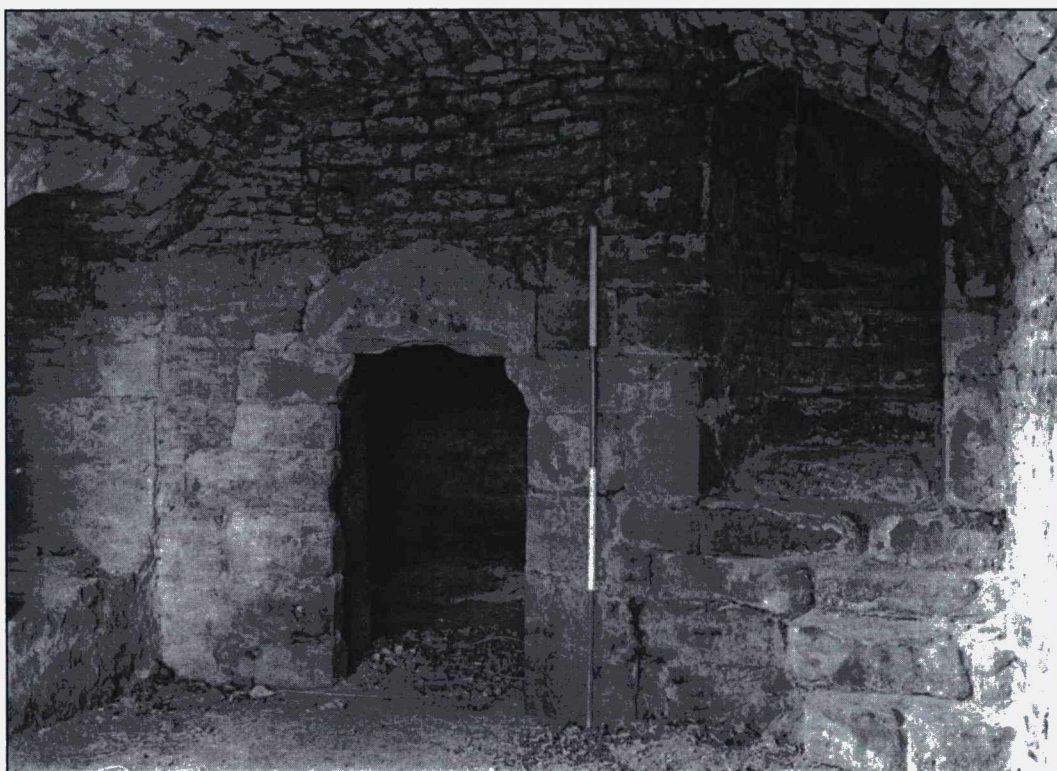
Plate 6: West side of room D prior to consolidation, looking W (photo 2/4).

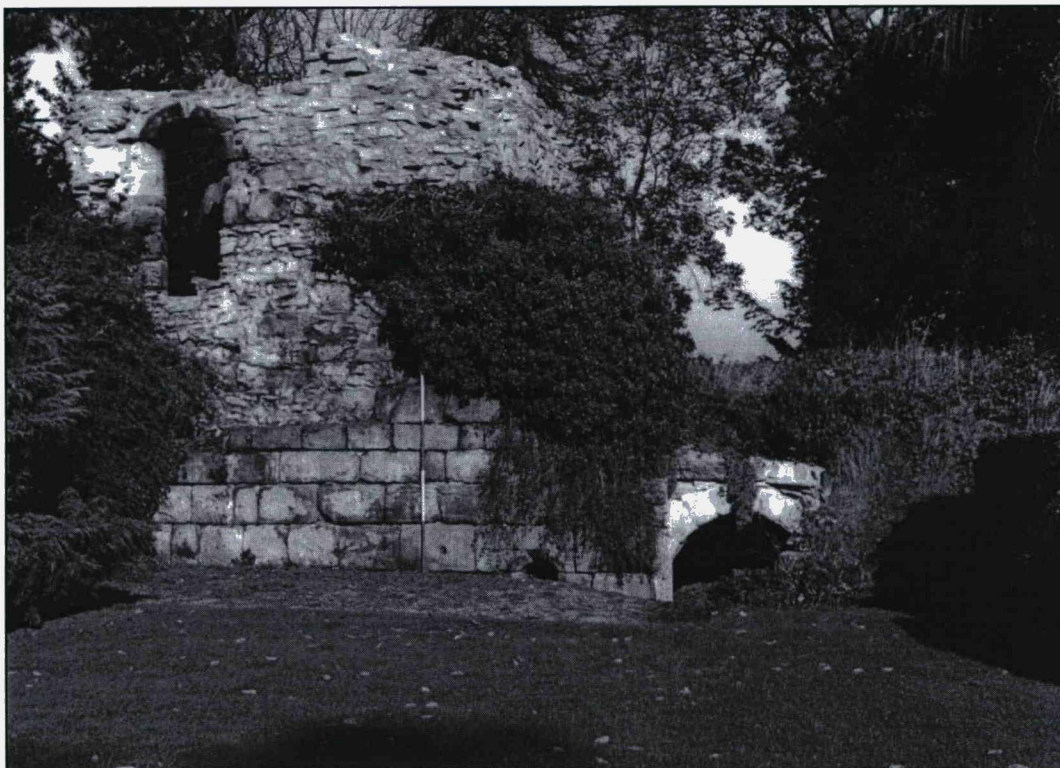
Plate 7: South elevation after consolidation, looking N (photo 7/1).

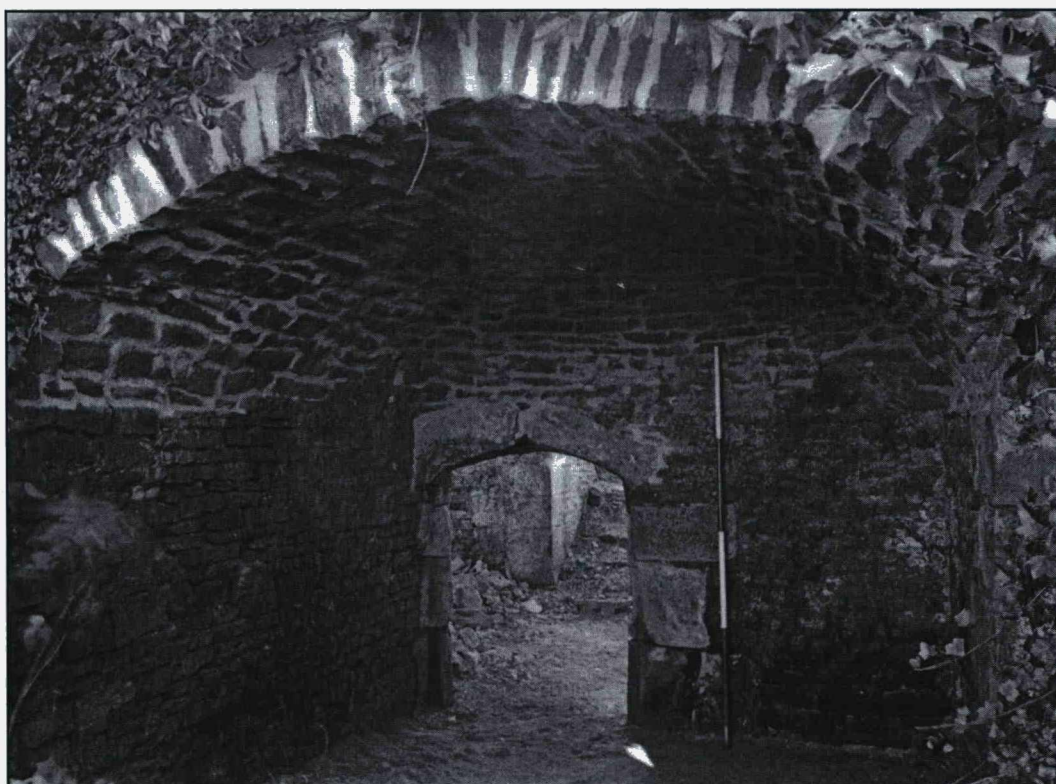
Plate 8: View into room E after consolidation, looking S (photo 7/13).
