Issue 01 November 2016 Steve Hill

## CRAYKE CASTLE, CRAYKE, NORTH YORKSHIRE, GAZETTEER CONTENTS

This Gazetteer has been written to accompany the Conservation Management Plan for Crayke Castle. It is a record of the building as its stands in August 2016 and is intended for use as a reference guide to allow anyone planning changes, from a professional considering major works to maintenance contractors dealing with ad hoc repairs, to quickly check the status of a room or building. The Gazetteer should also alert readers to the fact that they need to refer to the wider Conservation Management Plan, undertake further investigation before carrying out work that could have an impact on historic significance or apply for the relevant permission for work.

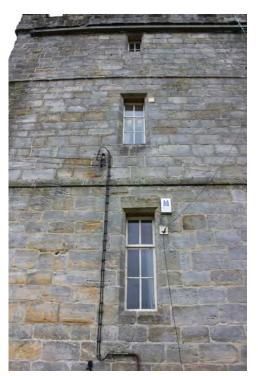
General view showing cabling etc

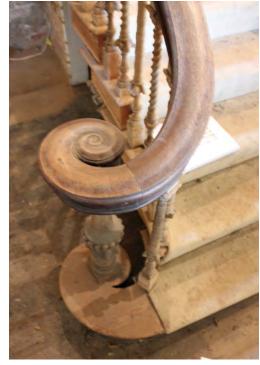
An absence of balusters at the curtail

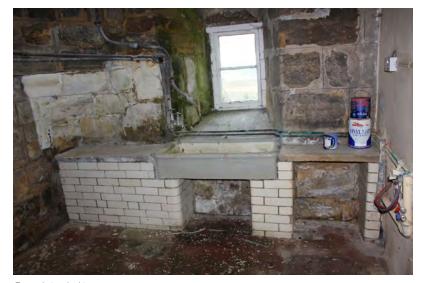
KEY FEATURES		INTRUSIVE FEATURES	
•	Evidence of spiral staircase in south-west corner	•	Poor overall condition with widespread damp
•	Nineteenth century scullery fittings Stone walls and medieval doorcase	•	Lead pipework

General view looking west

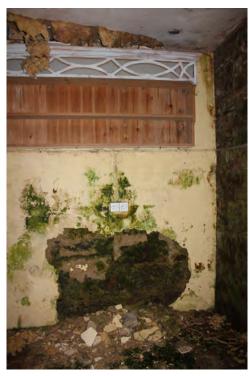
East wall - eroded plaster reveals stone wall behind

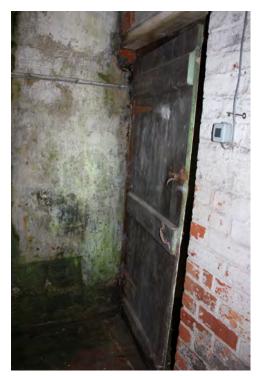
North wall – a combination of stone and brick

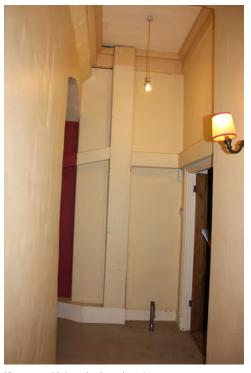
View east with intrusive boxed services

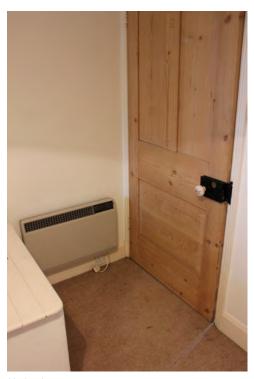
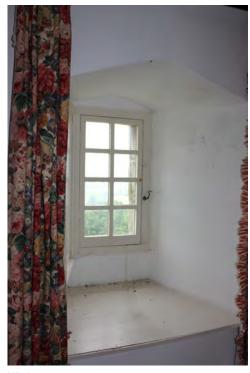
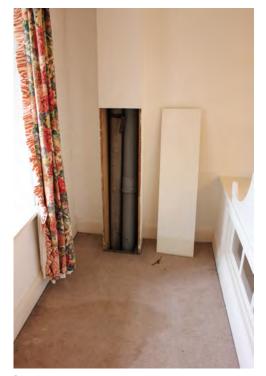
CEILING	Painted plaster.
WALLS	Papered plaster and paint. Plain chamfered skirting.
FLOORS	Carpet laid over floorboards.
DOORS	Three-panel timber door to Third Floor Corridor (TF0I) in north wall with moulded timber architrave.
WINDOWS	Eight-light timber casement set in a deep arched splay and timber sill. Internal timber shutter. Exposed stonework to surround.
	Borrowed lights to stairwell (see Stair SF08)
OTHER FEATURES	Electric heater on west wall behind door.
12/11/01/20	Built in timber bed frame above stairwell, broken pediment timber headboard.
	Boxed in services.

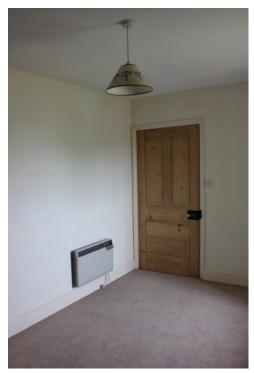
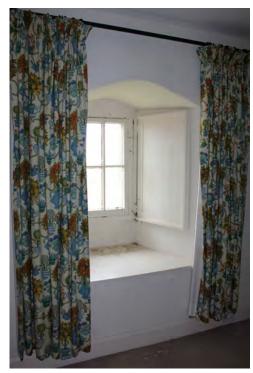
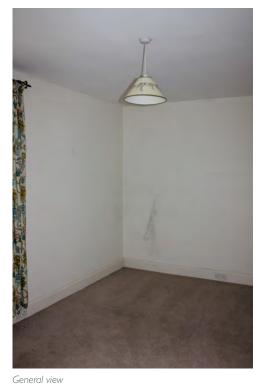
CEILING	Painted lathe and plaster.
WALLS	Painted plaster with chamfered skirting.
FLOORS	Carpet laid over floorboards.
DOORS	Three-panel timber door to and Third Floor Corridor (TF01) in north wall with moulded timber architrave.
WINDOWS	Eight-light timber casement set in a deep arched splay and timber sill. Internal timber shutter. Exposed stonework to surround.
FEATURES	Electric heater on west wall behind door.
	Part of chimney breast in corner of east wall.

KEY FEATURES	INTRUSIVE FEATURES
<ul><li>Original window opening.</li><li>Three-panel timber door</li></ul>	<ul><li>Modern fixtures.</li><li>Damp.</li></ul>

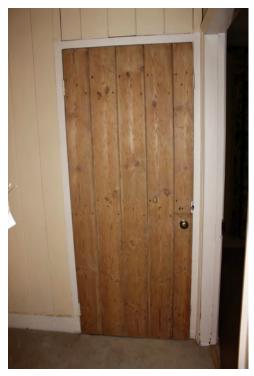
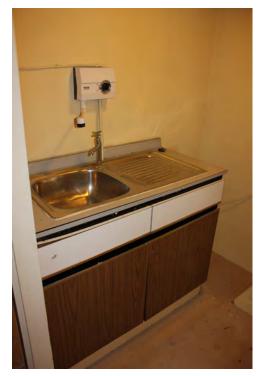
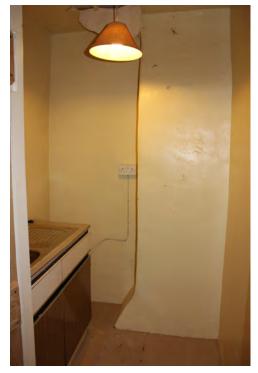
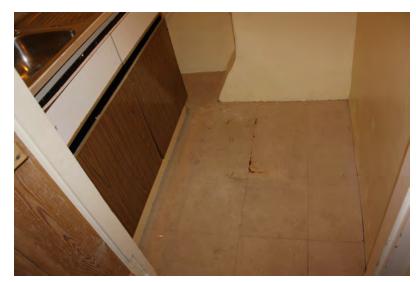
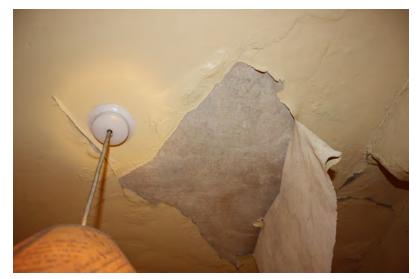
CEILING	Painted plaster. The modern paint is peeling to reveal gypsum plaster behind.
WALLS	Painted plaster. Painted tongue and groove partition separated room from corridor.
FLOORS	Marley floor tiles.
DOORS	Timber ledged and braced to Corridor (TF01).
WINDOWS	N/A
OTHER FEATURES	1970s kitchen cupboards and sink.  Electric water heater.  Evidence of flue (as seen in Bedroom 8 (TF08)) in east wall. Chimney breast also seen in Bedroom TF08.

KEY FEATURES	INTRUSIVE FEATURES
Chimney breast.	<ul><li>Modern fixtures.</li><li>Current condition.</li></ul>

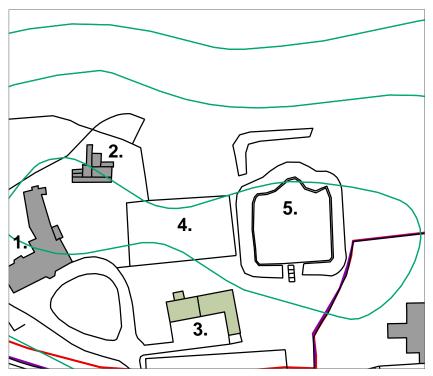
The garage and store are identified as number 3 in this plan

ROOF	Slate roof to rectangular building behind a rendered crenelated parapet. Asbestos sheet roof to stables and western lean-to. Corrugated metal roof to eastern lean-to.
WALLS	Rendered brick to rectangular building and timber walls to stables. The lean-to to the west is in timber and in breeze block to the east.
SURFACE TREATMENTS	Gravel, stone cobbles and grass
DOORS	Large timber sliding garage doors to rectangular brick building with timber ledged and braced doors stable-style doors. Double ledged and braced doors to western lean-to.
WINDOWS	Brick structure: Six-over-six light timber sliding sash window to west elevation.  A number of panes missing. Narrow, six light timber casement to northern elevation.  Stable: Timber stable windows with glazed top opener and vented slats to lower window.
	Six light timber casements to lean-tos.
OTHER FEATURES	Whilst not inspected internally, a small room at the western end of the building could be viewed through a window. The remains of what appeared to be a cast iron range could be seen. The walls were painted brick and the ceiling was lath and plaster.

KEY FEATURES	INTRUSIVE FEATURES
Crenelated parapet.	<ul><li>Inserted garage doors.</li><li>Current condition.</li></ul>
