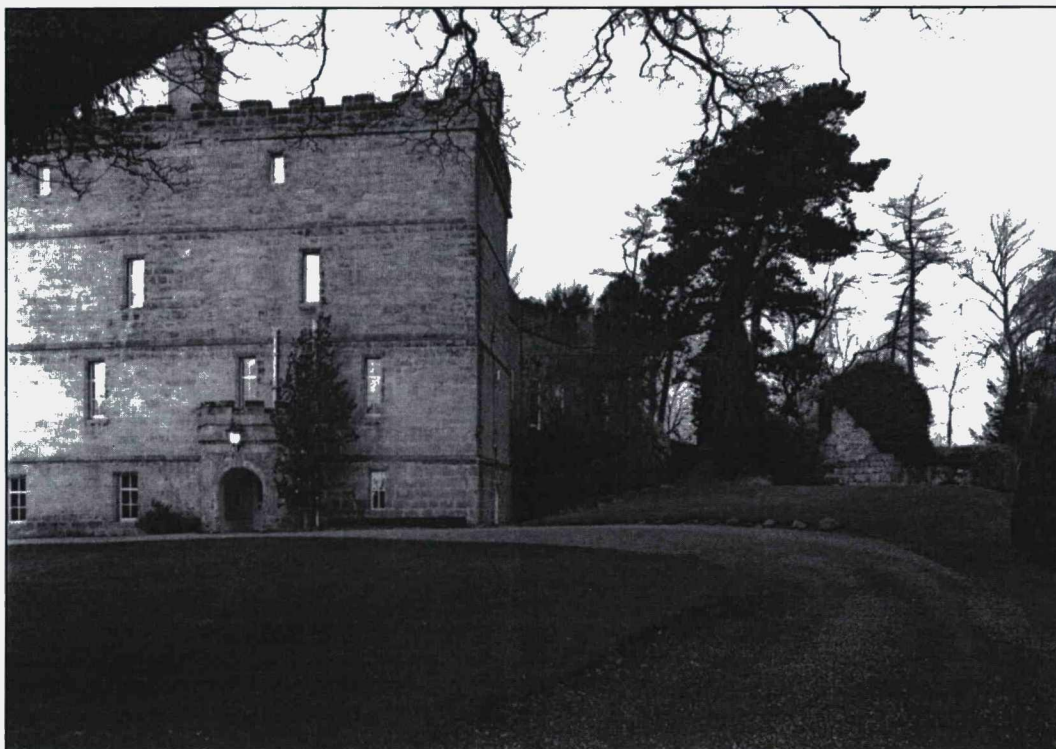
Plate 1: General view of site, showing relationship between residential block and the ruined "New Tower", looking N (photo 1/15).
